# Hurricane Ike in Texas and Louisiana

Building Performance Observations, Recommendations,  
and Technical Guidance

FEMA P-757 / April 2009

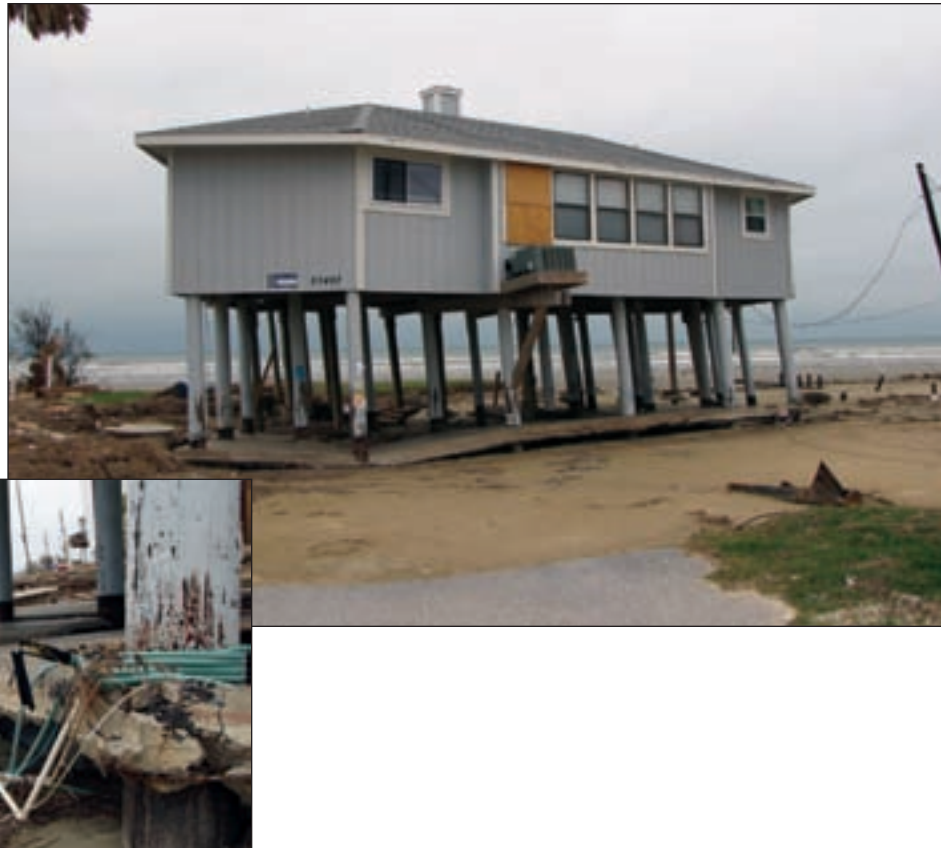
**Figure 3-21.**  
Failure of a timber pile foundation undermined by scour and erosion. Inset shows close-up of concrete slab failure and rotation of some of the foundation piles (Galveston Island, TX; Zone V).

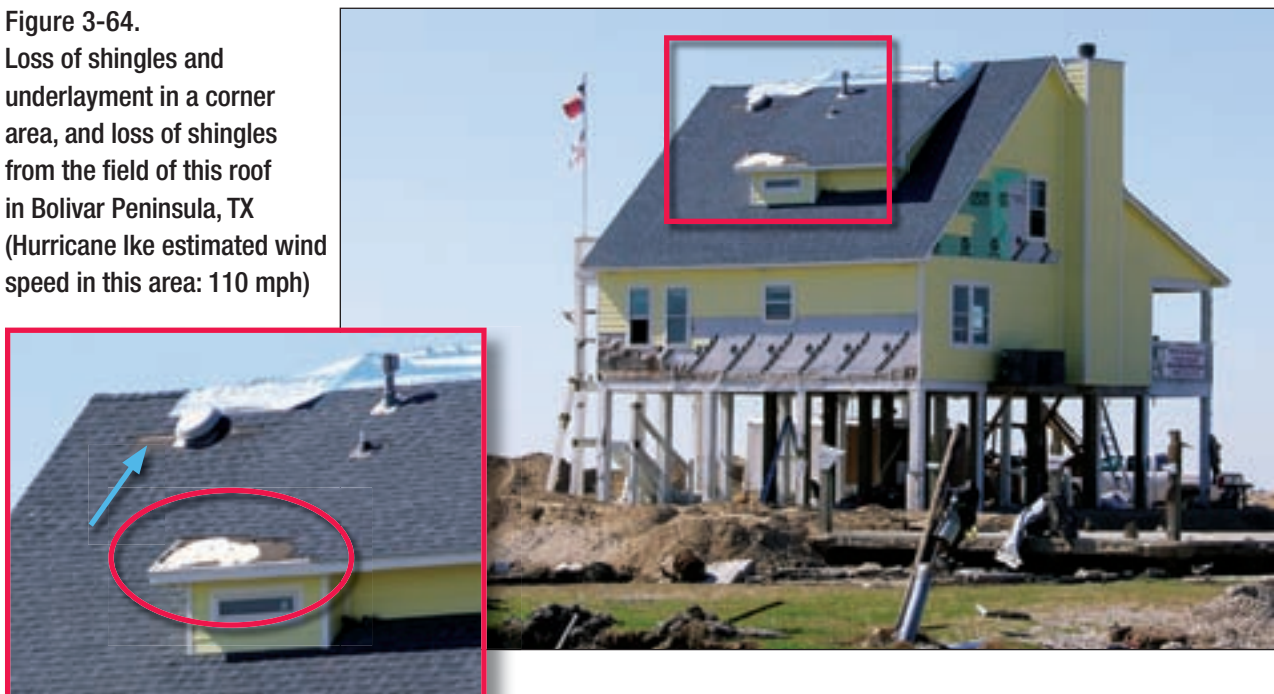
**Figure 3-64.**  
Loss of shingles and underlayment in a corner area, and loss of shingles from the field of this roof in Bolivar Peninsula, TX (Hurricane Ike estimated wind speed in this area: 110 mph)

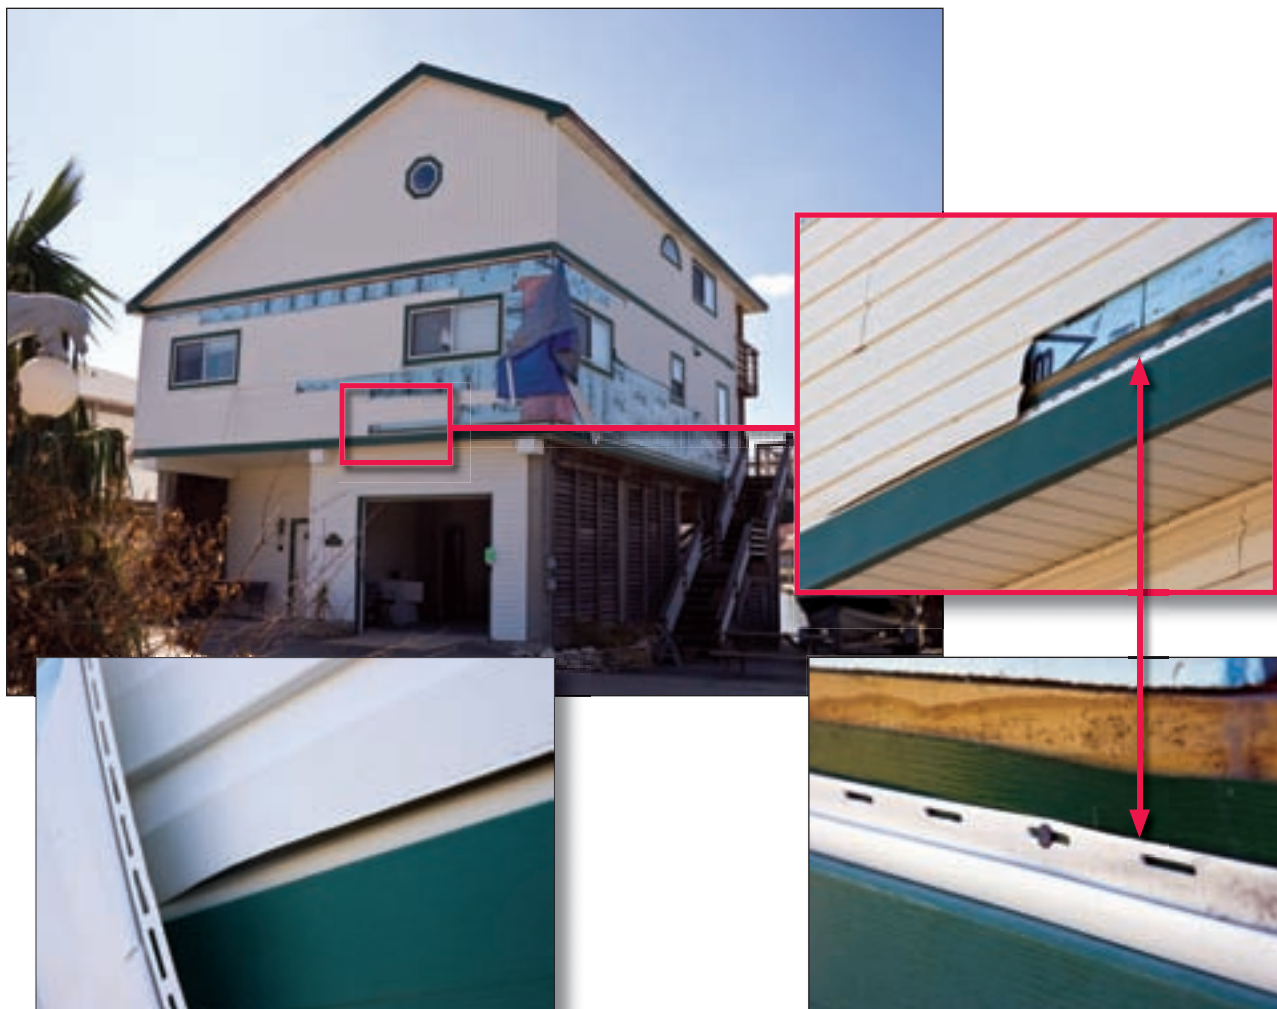
**Figure 3-81.** Improper installation led to extensive loss of siding up the house wall. The bottom lock of the lowest course of siding was cut off, and utility trim substituted for the correct starter strip. The poorly retained bottom edge pulled out under wind pressure, leading to extensive loss of siding up the house wall (Tiki Island, TX; Hurricane Ike estimated wind speed in this area: 88 mph, Exposure B).

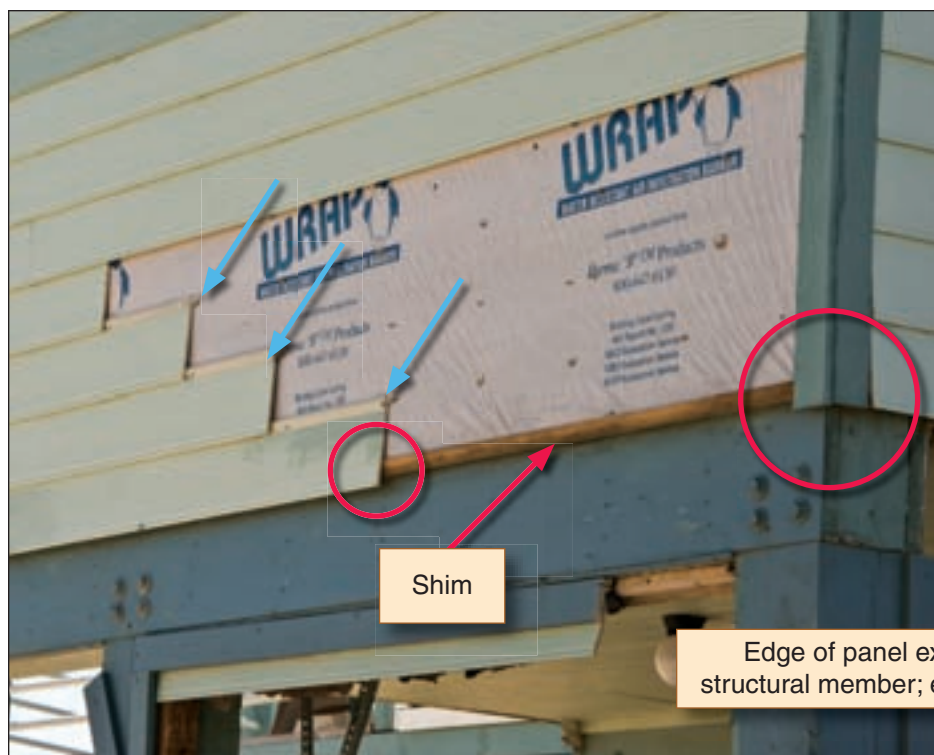
Figure 3-91. Shim placement (red arrow) allowed the lower edge (red circles) of siding to be exposed, resulting in loss of siding at several locations around this elevated structure on Bolivar Peninsula, TX. Note the blind nailing shown by blue arrows (Hurricane Ike estimated wind speed in this area: 110 mph, Exposure C).

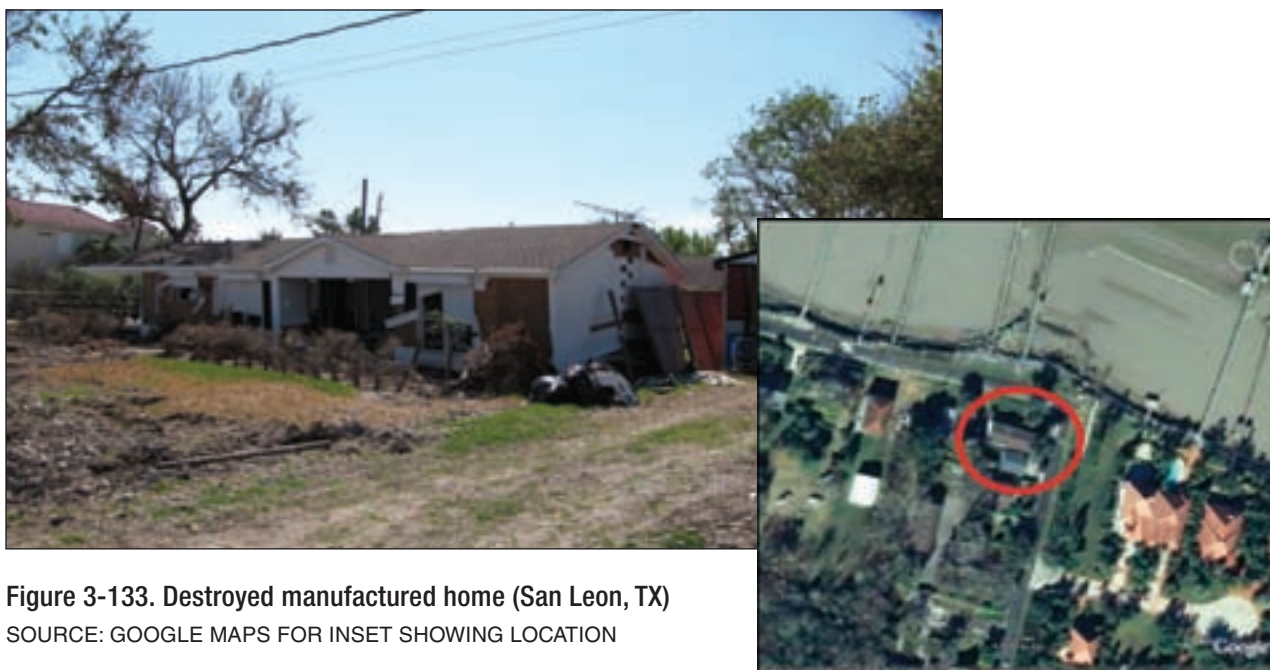
**Figure 3-133. Destroyed manufactured home (San Leon, TX)**

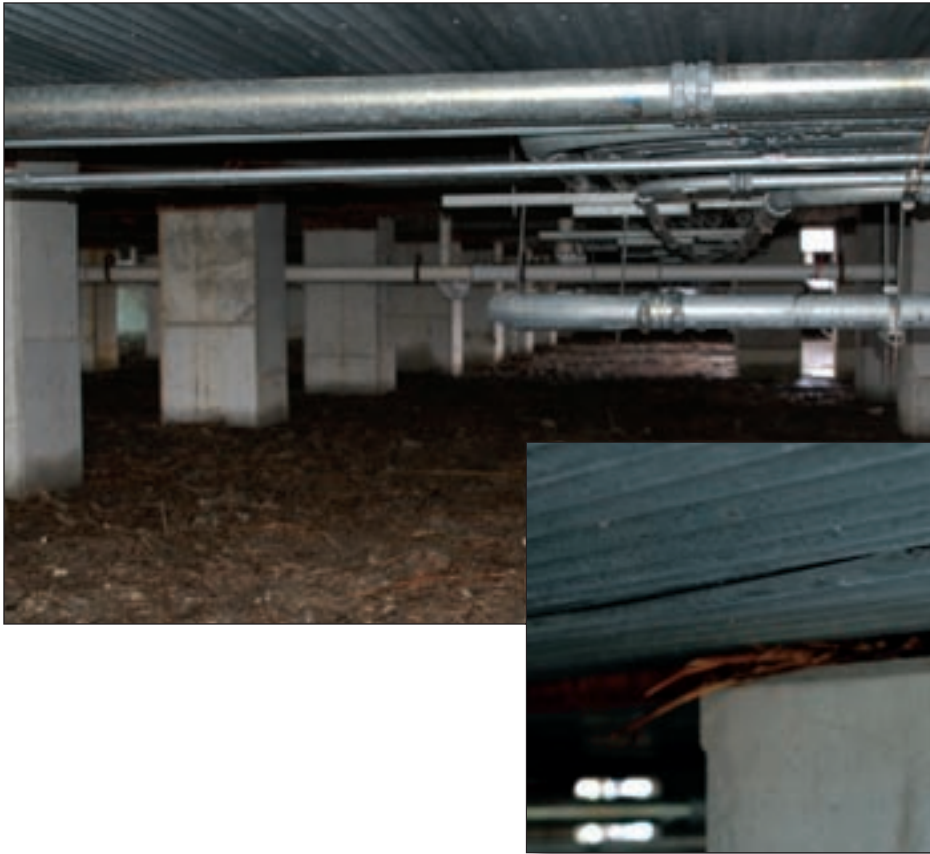
Figure 4-33.  
Conduits and pipes  
beneath South Cameron  
Parish Hospital. Vegetation  
was noted between the  
floor system and the steel  
plate of the foundation. A  
connection between the  
plate and the floor system  
was not visible.

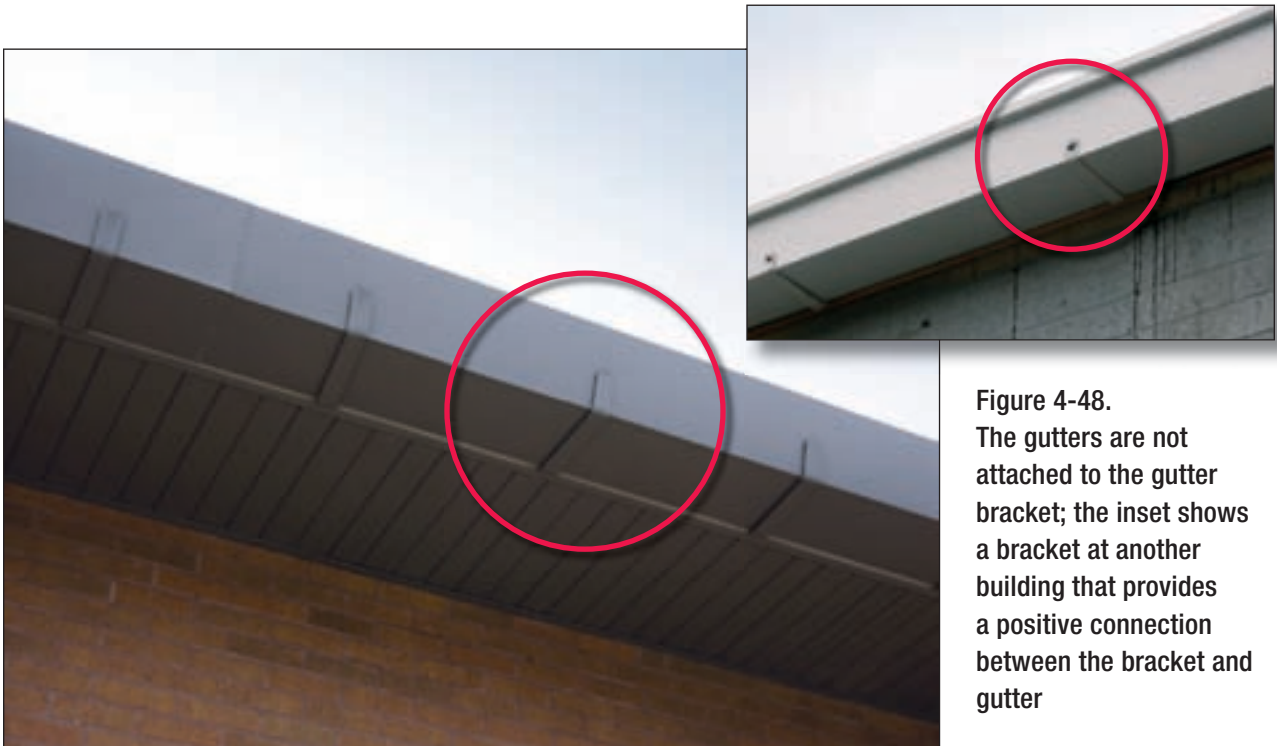
Figure 4-48.  
The gutters are not  
attached to the gutter  
bracket; the inset shows  
a bracket at another  
building that provides  
a positive connection  
between the bracket and  
gutter

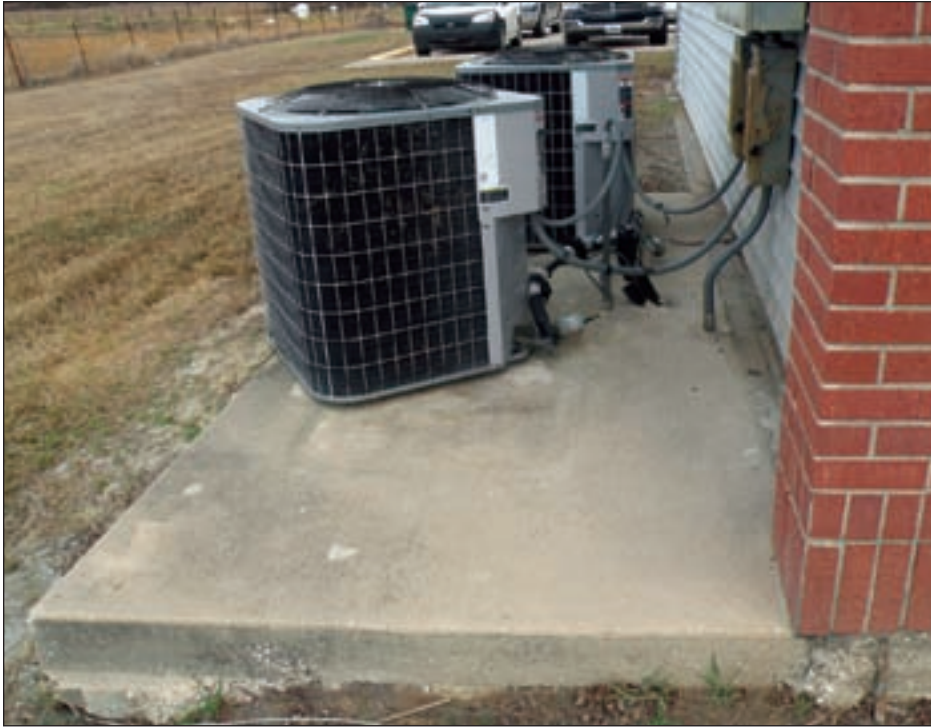
Figure 4-58.  
Condenser units were installed at Hackberry Fire Station after Ike and are vulnerable to future flooding

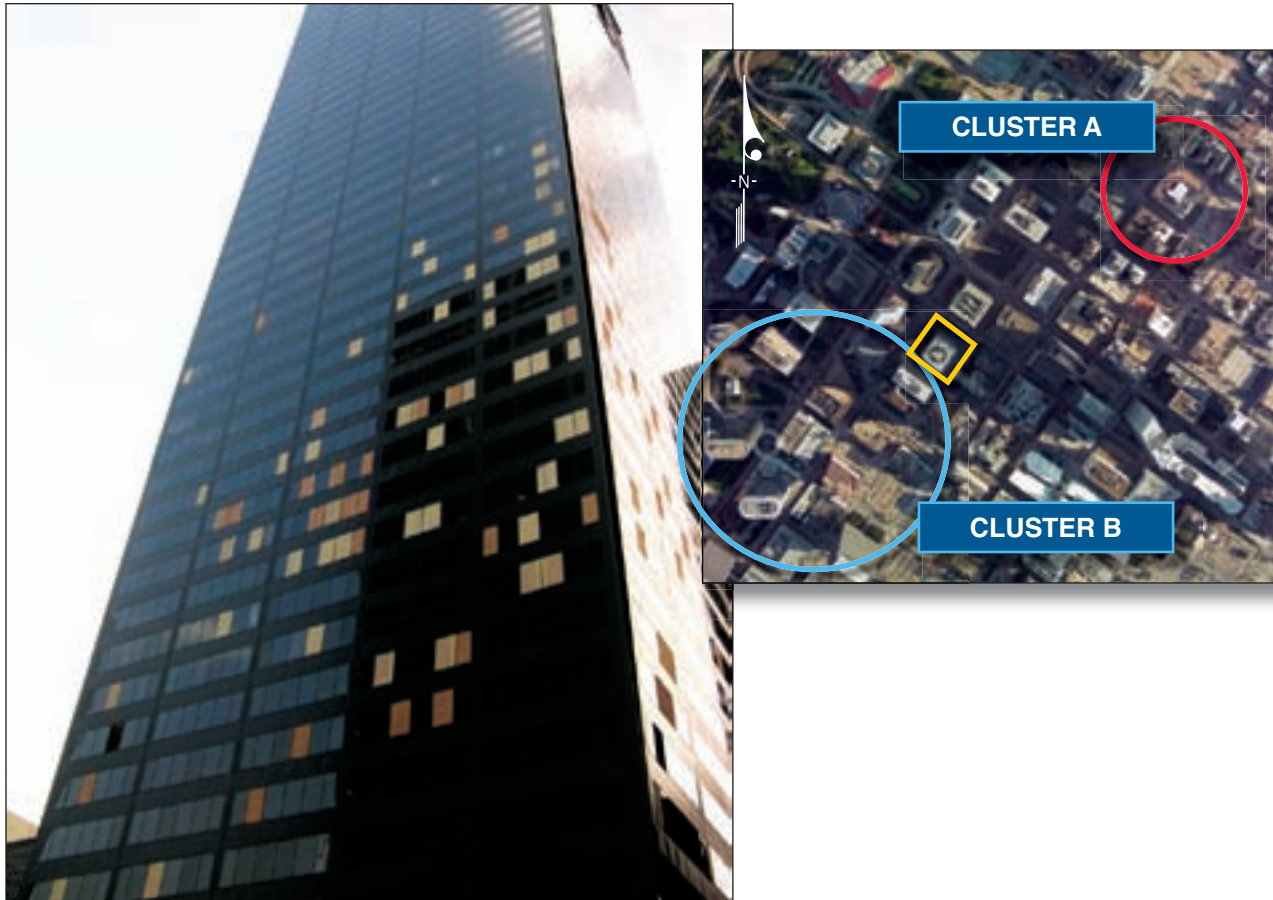
**Figure 5-2.**  
Building with glazing damage; location shown by yellow square in inset

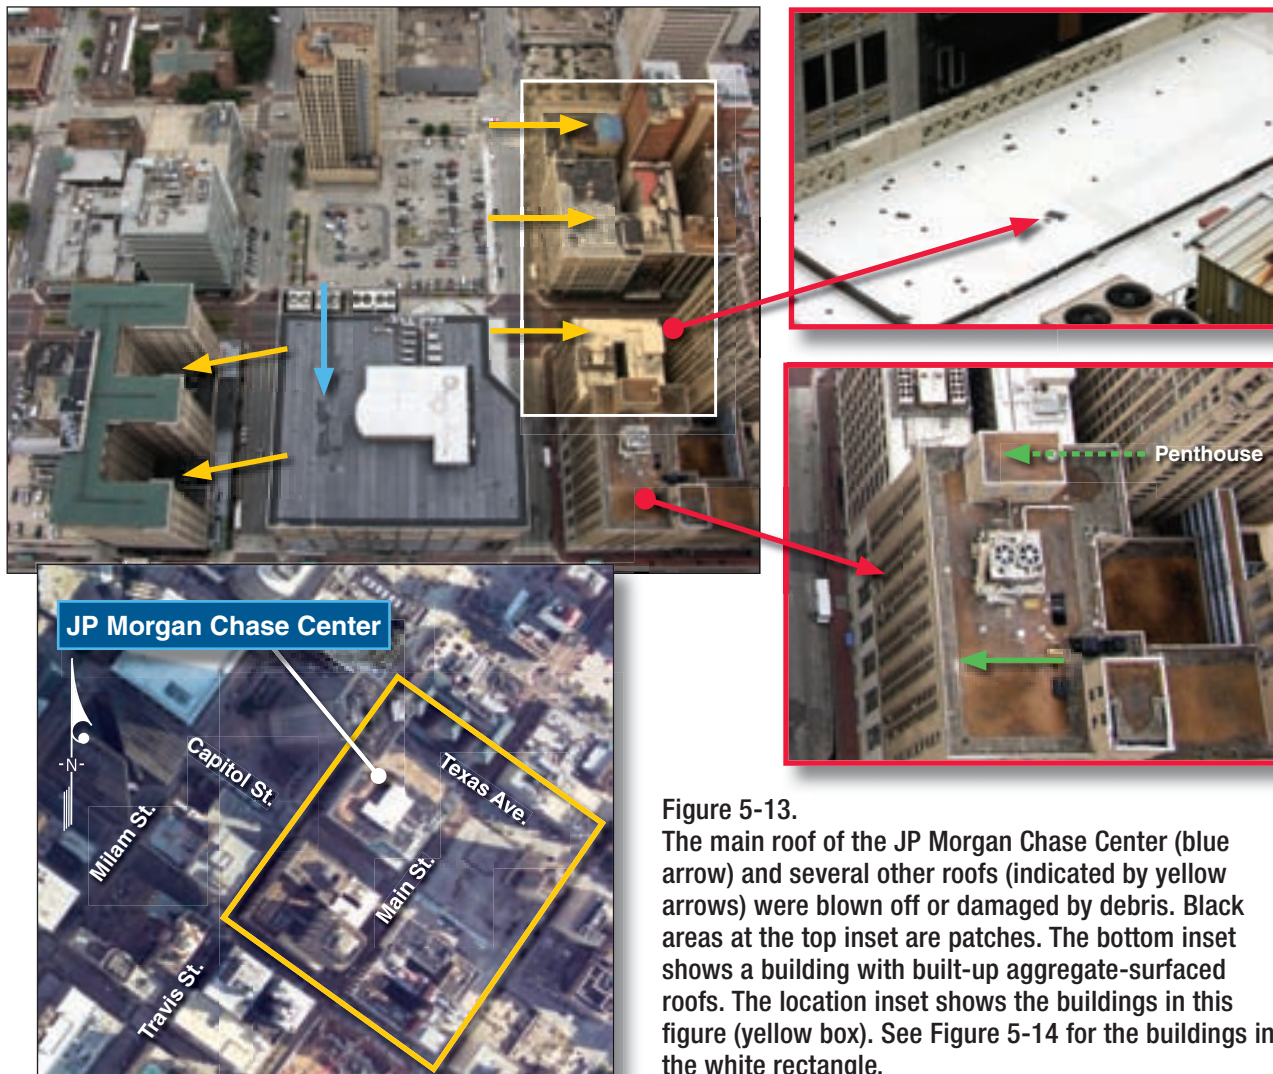
Figure 5-13. The main roof of the JP Morgan Chase Center (blue arrow) and several other roofs (indicated by yellow arrows) were blown off or damaged by debris. Black areas at the top inset are patches. The bottom inset shows a building with built-up aggregate-surfaced roofs. The location inset shows the buildings in this figure (yellow box). See Figure 5-14 for the buildings in the white rectangle.

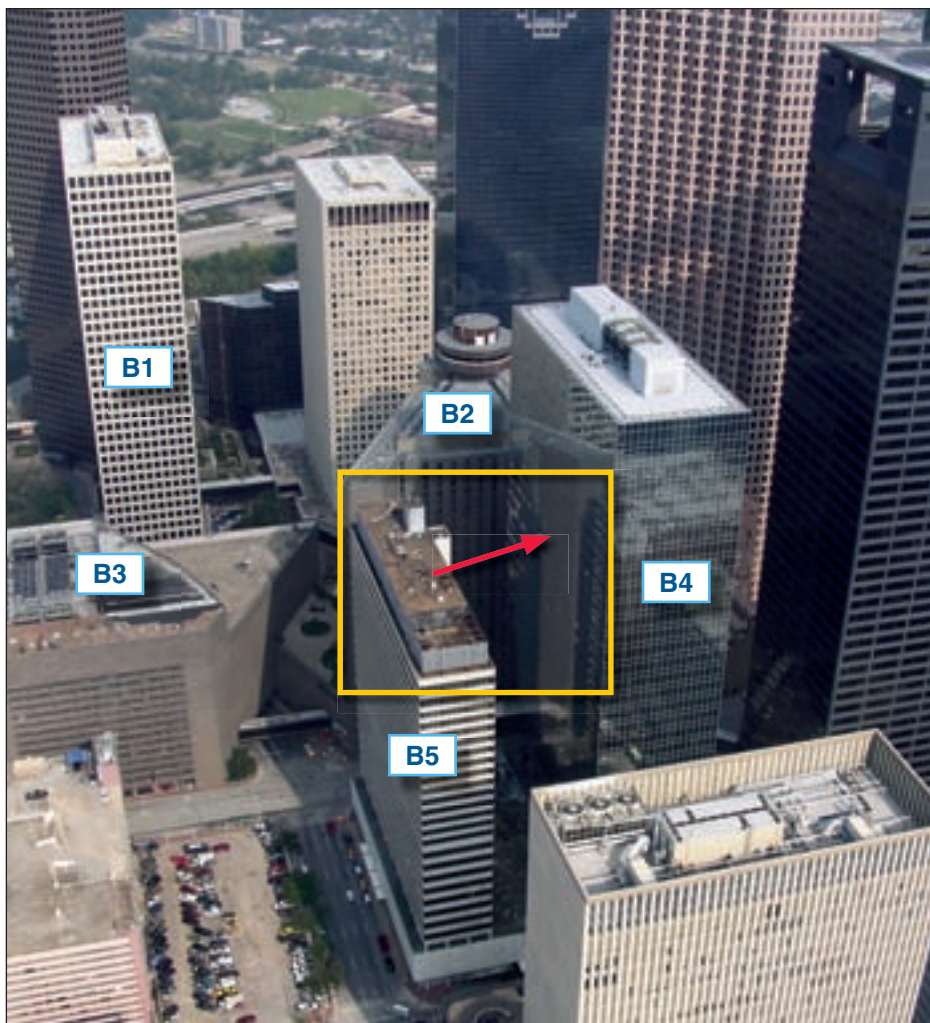
Figure 5-25.  
Roof aggregate from  
building B-5 was the  
likely cause of the  
majority of the building  
B-4 glass damage. The  
area in the yellow box is  
shown in Figure 5-26.

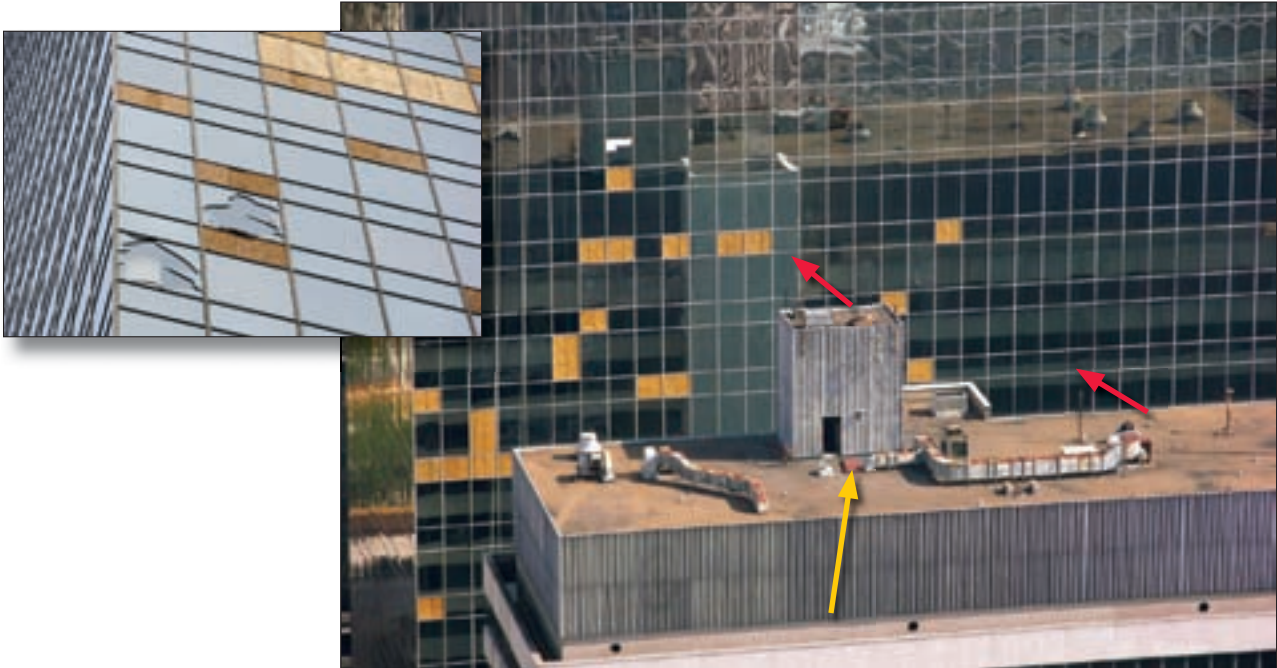
**Figure 5-26.**  
View of the aggregate-surfaced roofs on building B-5 and broken glazing on building B-4 beyond. Red arrows indicate generalized aggregate flight path. The yellow arrow shows a penthouse door that blew off. Inset shows damage on a portion of building B-4 below the area shown in the main photograph.

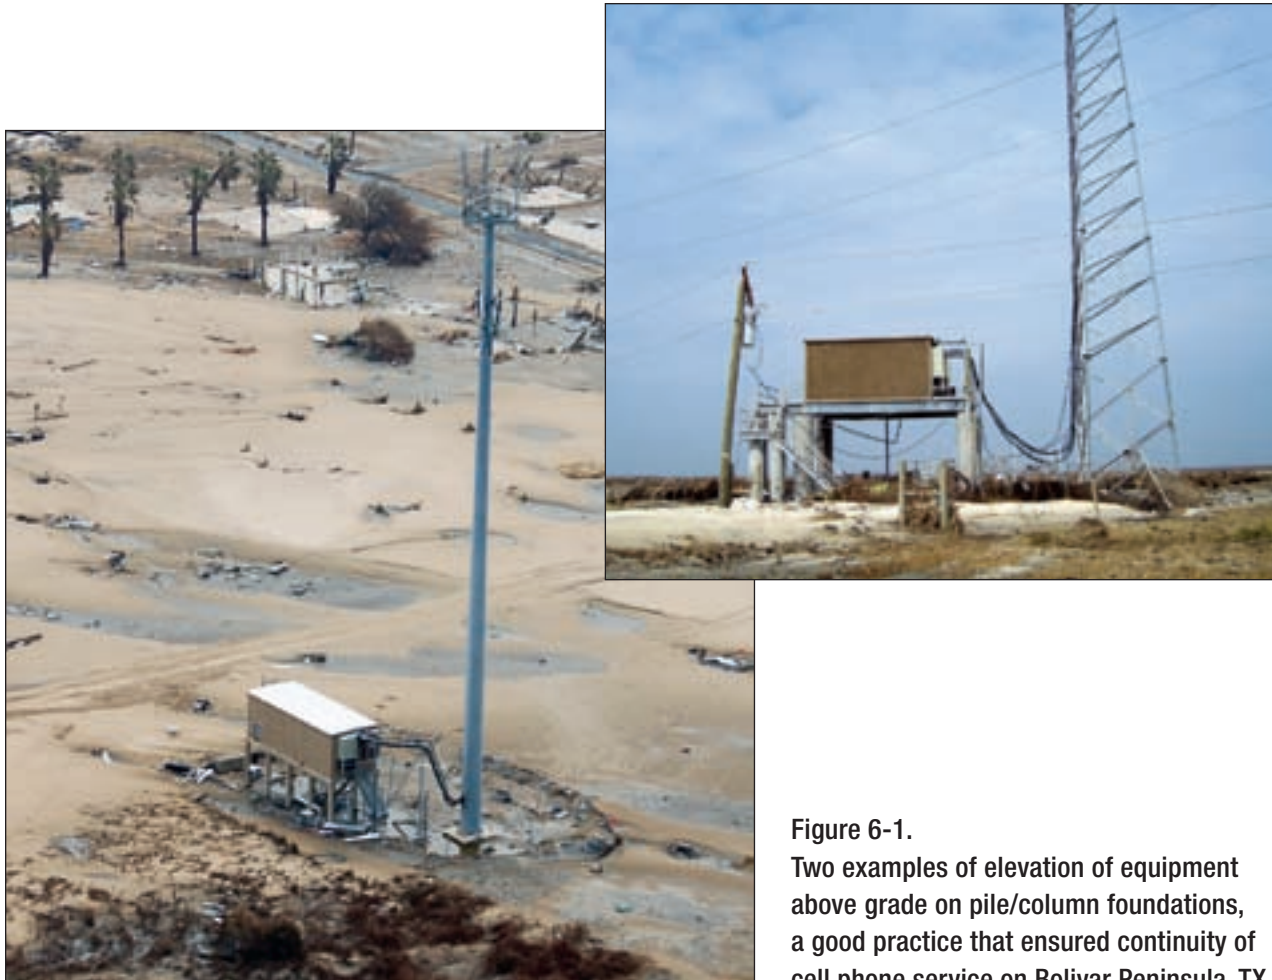
Figure 6-1.  
Two examples of elevation of equipment  
above grade on pile/column foundations,  
a good practice that ensured continuity of  
cell phone service on Bolivar Peninsula, TX
